INTERTEK TEST REPORT #3099991

IMPACT RESISTANCE

INSPIRE SLATE (CLASS C FORMULA)
SIMULATED SLATE ROOFING TILES

INTERTEK TEST REPORT #3099991
MODEL: INSPIRE SLATE
CLIENT: INSPIRE ROOFING PRODUCTS
TEST DATE: JUNE 30, 2006

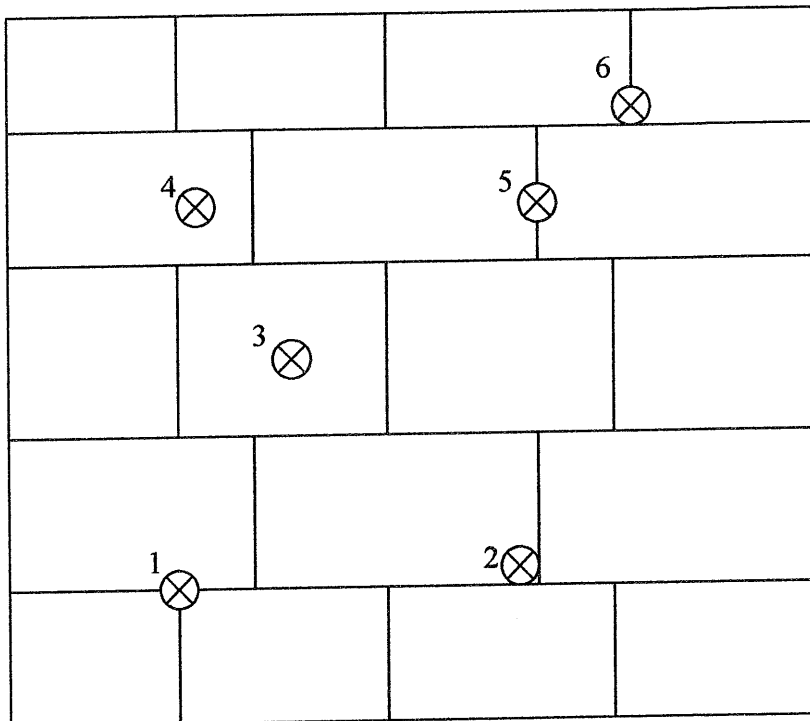
IMPACT LOCATIONS

A 3 foot by 3 foot square base frame was constructed, using nominal 2 inch by 4 inch wood studs, with a stud positioned centrally, running parallel to the edges. The frame was sheathed with 15/32 inch A-C Grade plywood, with the 'A' side facing up. The roofing material was applied with the recommended maximum exposure of 7-1/4 inches using galvanized 1-1/2 inch long roofing nails with 3/8 inch diameter heads (2 nails per tile). All materials used in construction of the test samples were stored at ambient temperatures of approximately 70 degrees F for 48 hours prior to testing. The test decks were then placed on a concrete floor and a 2 inch diameter stainless steel ball, weighing 1.18 lbs., was elevated to 20 feet with an electromagnetic clamp and then released. The ball was dropped twice on the same impact location, and depression measurements and observations were made. This procedure was repeated for 6 different impact locations on each test deck. Observations were made using 5X magnification.

<u>Drop Location</u>	<u>Distance Between Depressions</u>	<u>Depth of Depression</u>	<u>Observations</u>
Edge over Seam	Less than 1/2"	No Visible Depression	No evidence of tearing, fracturing, cracking, splitting, rupture, crazing, or other evidence of opening in the roof covering system
Corner	Less than 1/2"	No Visible Depression	No evidence of tearing, fracturing, cracking, splitting, rupture, crazing, or other evidence of opening in the roof covering system
Center	Less than 1/2"	No Visible Depression	No evidence of tearing, fracturing, cracking, splitting, rupture, crazing, or other evidence of opening in the roof covering system
Center	Less than 1/2"	No Visible Depression	No evidence of tearing, fracturing, cracking, splitting, rupture, crazing, or other evidence of opening in the roof covering system
Seam	Less than 1/2"	No Visible Depression	No evidence of tearing, fracturing, cracking, splitting, rupture, crazing, or other evidence of opening in the roof covering system
